DESIGN OF FLEXIBLE AIRFIELD PAVEMENTS FOR  
MULTIPLE-WHEEL LANDING GEAR ASSEMBLIES

REPORT NO. 1

TEST SECTION WITH LEAN CLAY SUBGRADE

TECHNICAL MEMORANDUM NO. 3-349

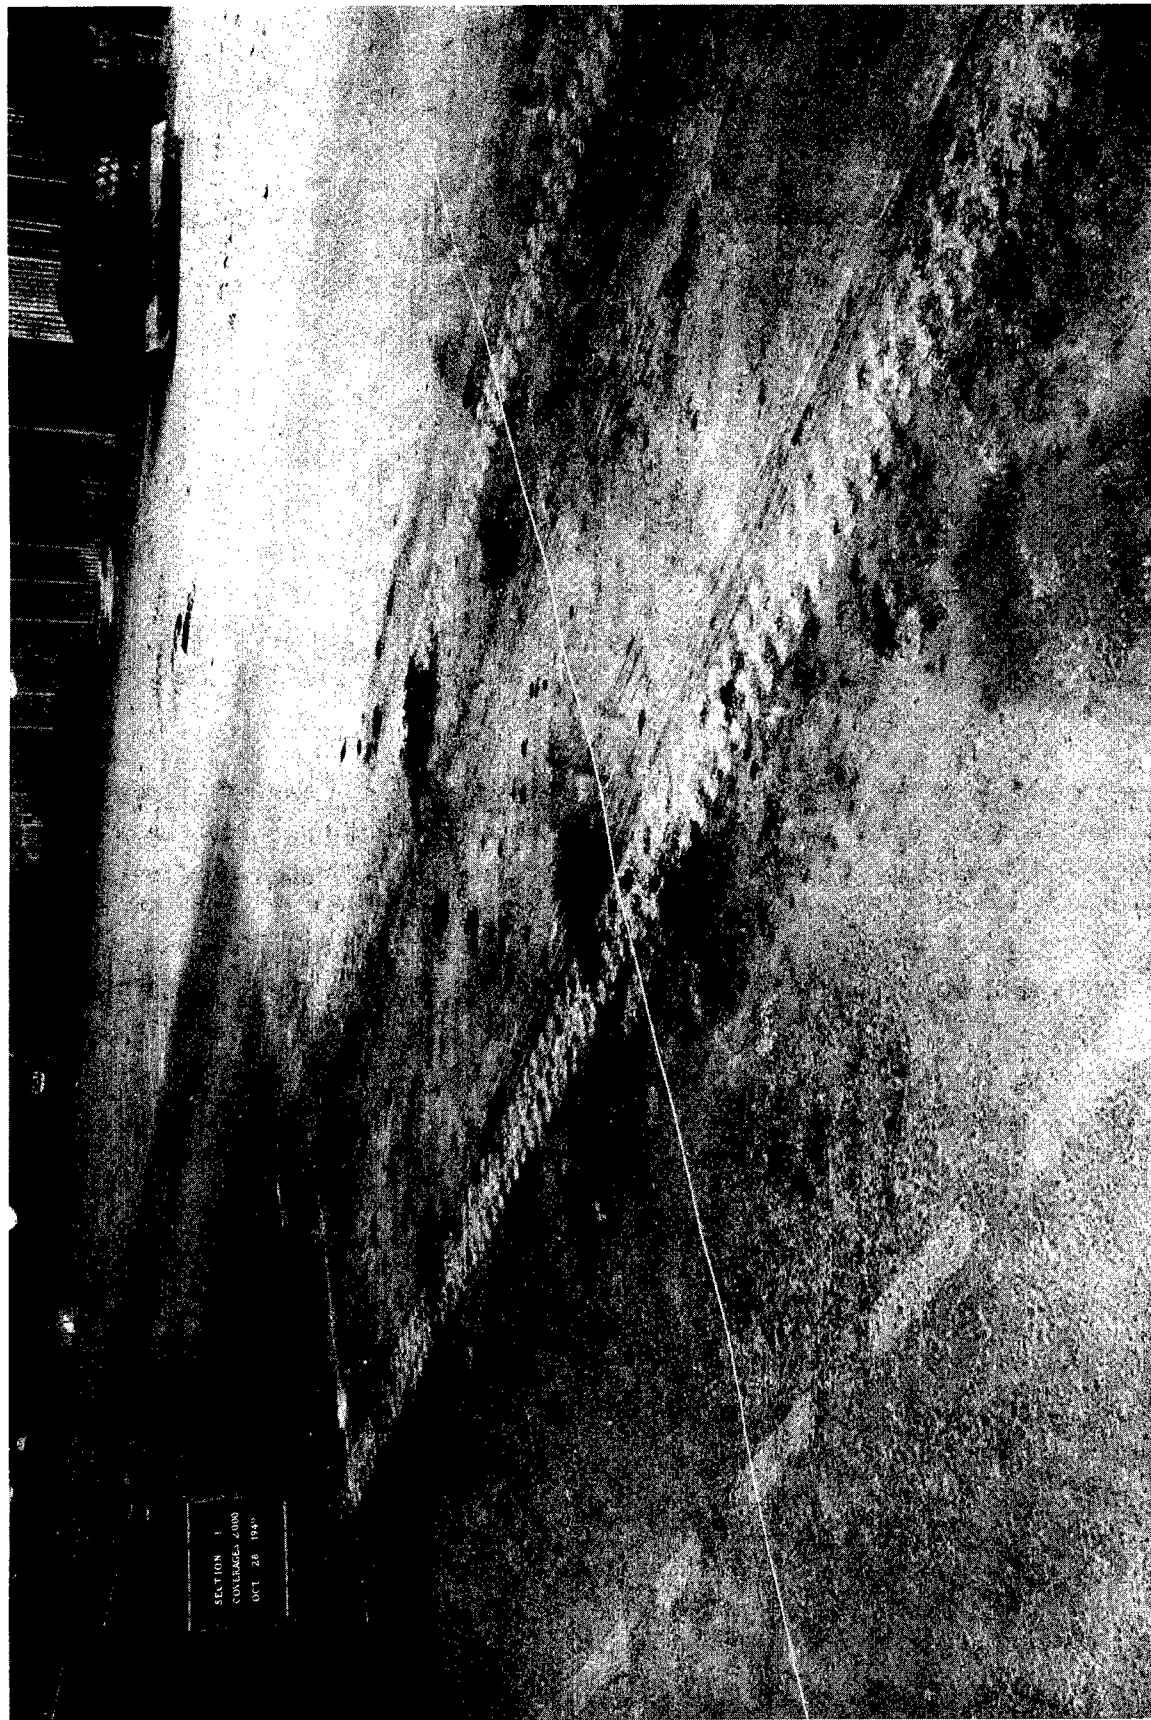
cent after 2,000 coverages (pit 26). An average CBR of 32 per cent is considered pertinent to this portion of the unit. The condition of the unit at the end of testing is shown in photograph 9.

Photograph 9. Unit 1, 14-in. thickness. View showing rutting after 2,000 coverages with 150,000-lb load on B-36 assembly

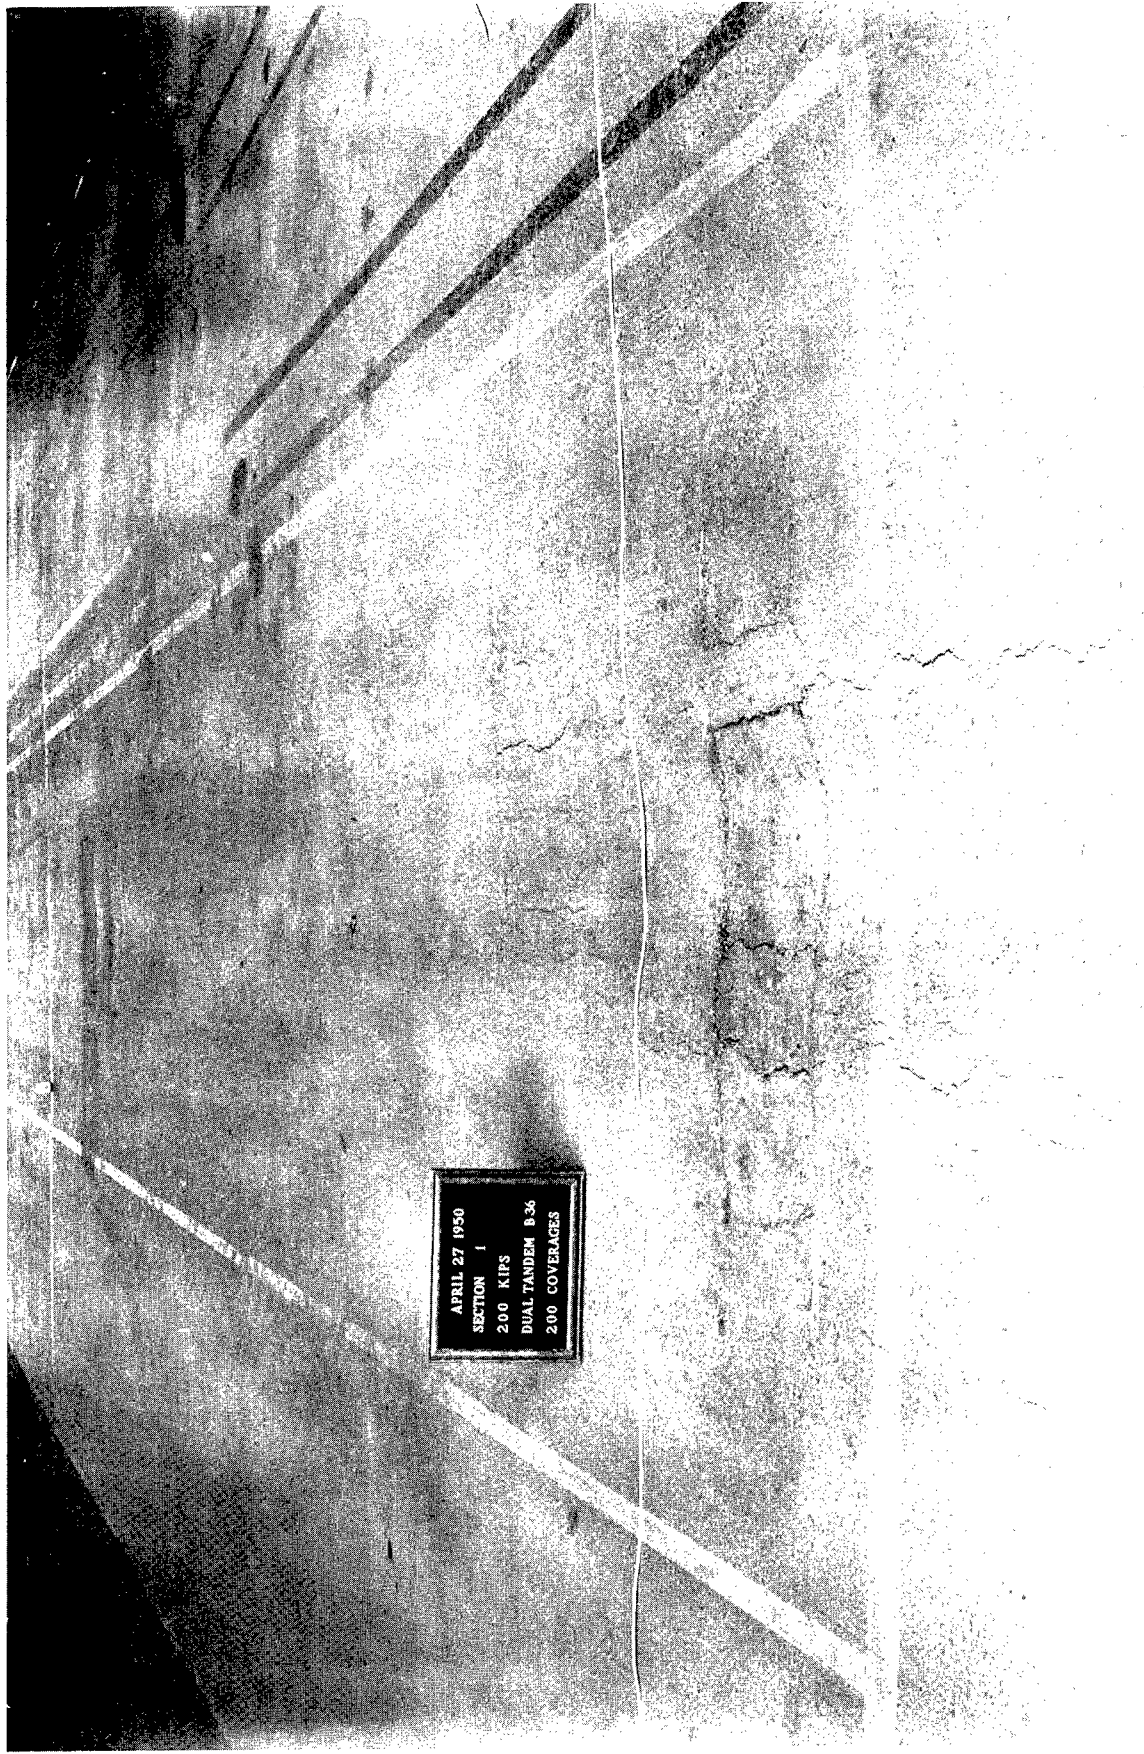
Unit 4 of the B-29 lane began to fail after 42 coverages of B-50 traffic and had completely failed after 328 coverages. The failure conditions in these units are shown in photographs 10, 11, 16, and 17. For convenience, the pertinent details of all test traffic are tabulated below:

Photograph 10. Unit 1, 14-in. thickness. View showing rutting and failure after 200 coverages with 200,000-lb load on B-36 assembly

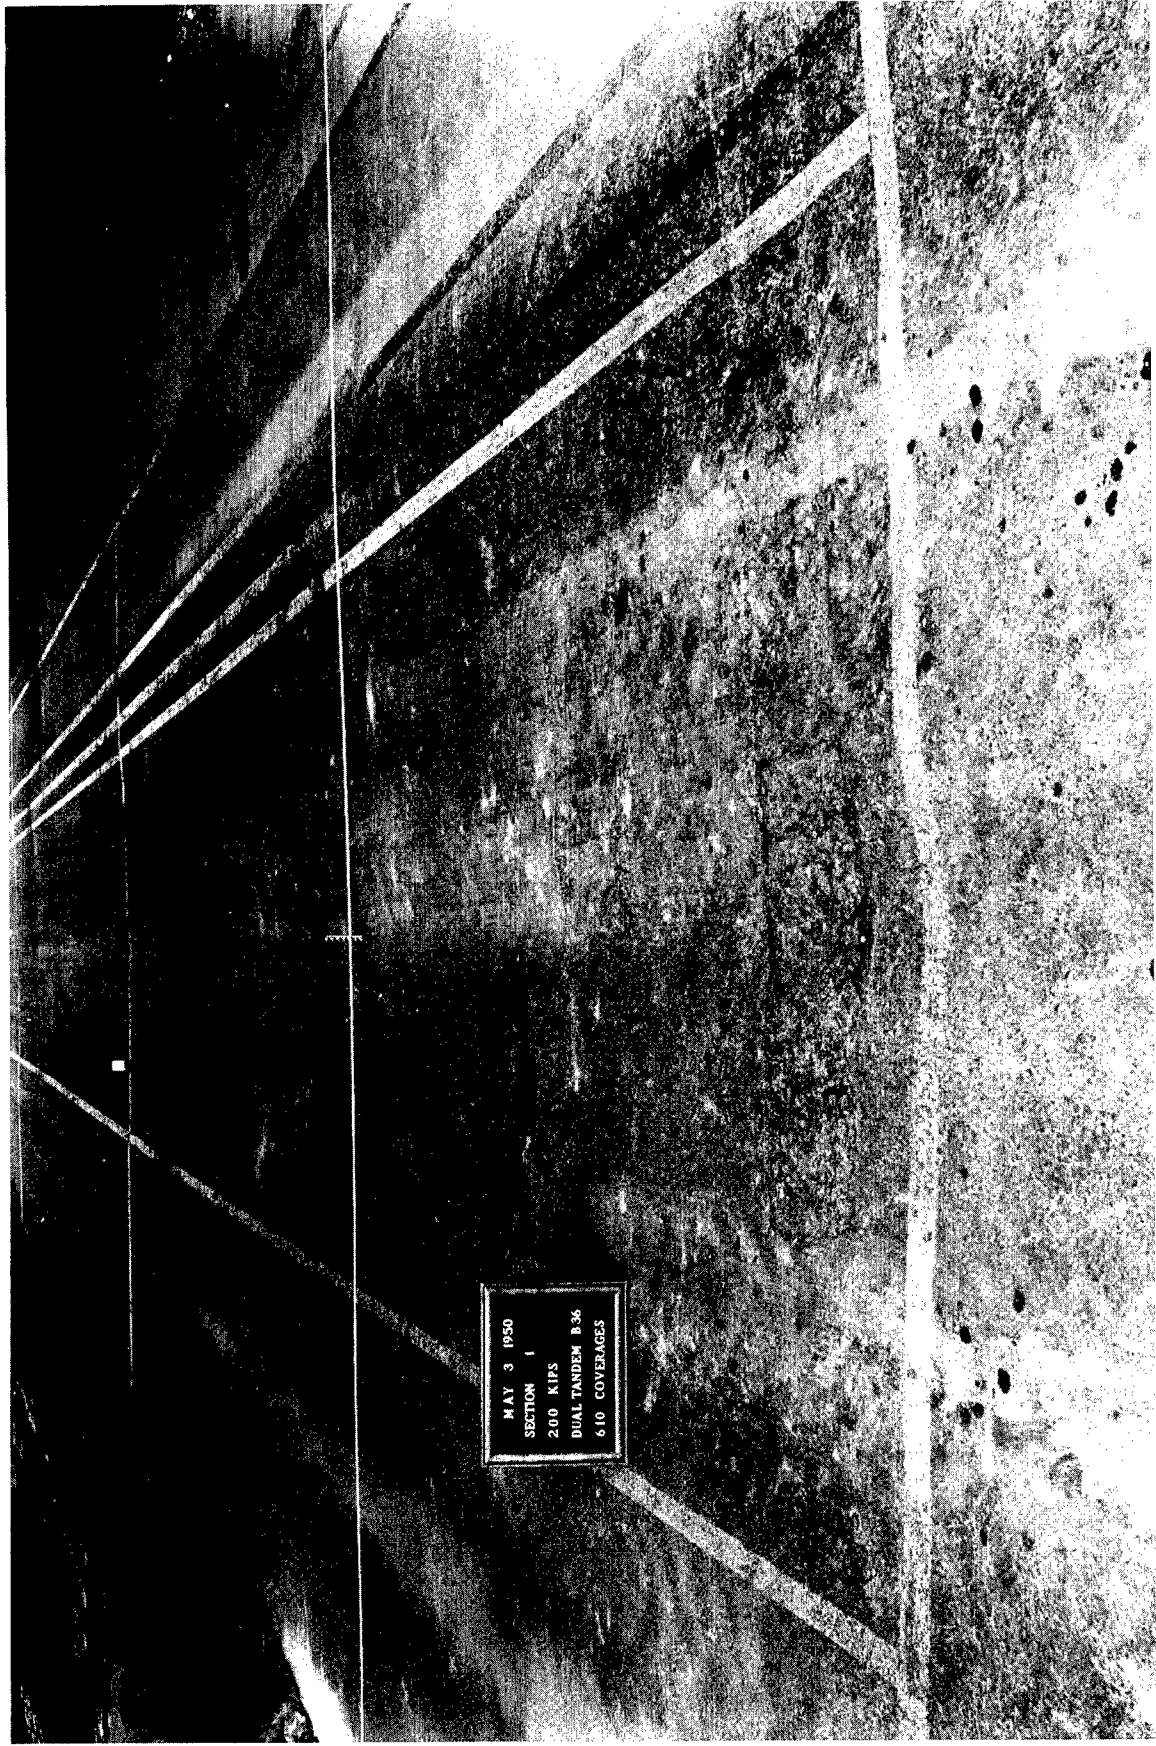
load increased from 0.233 in. at the first load application to 0.362 in. at 200 coverages. The maximum deformation of the surface was about 3.1 in (see plate 13) and the maximum deformation of the subgrade at the gage point was about 0.6 in. (see plate 11). Rutting and cracks resulting in failure developed in the south 10 ft of the unit between stations 0+00 and 0+10 after about 200 coverages. The entire unit was considered to have failed after 610 coverages. The failure conditions are shown in photographs 10 and 11. The CBR of the subgrade was 18 per cent after 460 coverages (pit 29) and was 13 per cent after 610 coverages (pit 30). The unit is evaluated as inadequate.

Photograph 11. Unit 1, 14-in. thickness. View after 610 coverages with 200,000-lb load on B-36 assembly

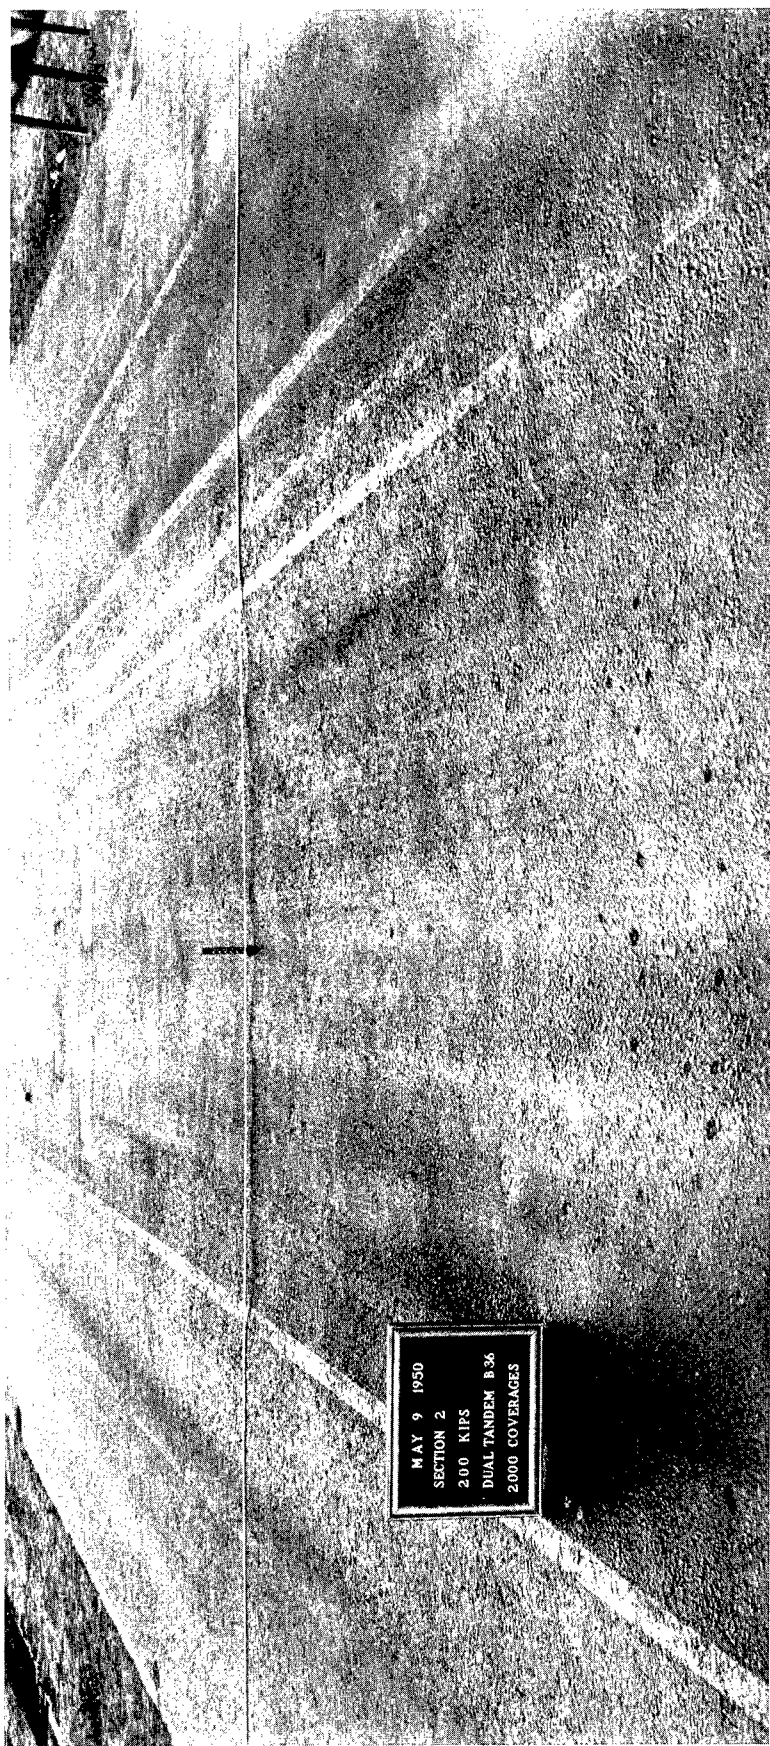
32. Unit 2, 20-in. thickness. The deflection of the subgrade under load increased from 0.214 in. at the first load application to 0.338 in. at 2,000 coverages. The maximum deformation of the surface was about 2.2 in. (see plate 13), and the maximum deformation of the subgrade at the gage point was about 0.3 in. (see plate 11). Rutting and moderately severe deformation appeared in this unit from the beginning of the 200,000-lb testing and became progressively worse. However, no cracking was observed except in the patch at pit 35. Photograph 12 shows the roughened surface and the degree of rutting which occurred in this unit after 2,000 coverages. The CBR of the subgrade was 26 per cent after 1,056 coverages (pit 35) and was 28 per cent after 2,000 coverages (average of pits 36 and 37). An average CBR of 27 per cent is considered pertinent to this portion of the unit. The unit is evaluated as borderline.

Photograph 12. Unit 2, 20-in. thickness. View showing rutting after 2,000 coverages with 200,000-lb load on B-36 assembly

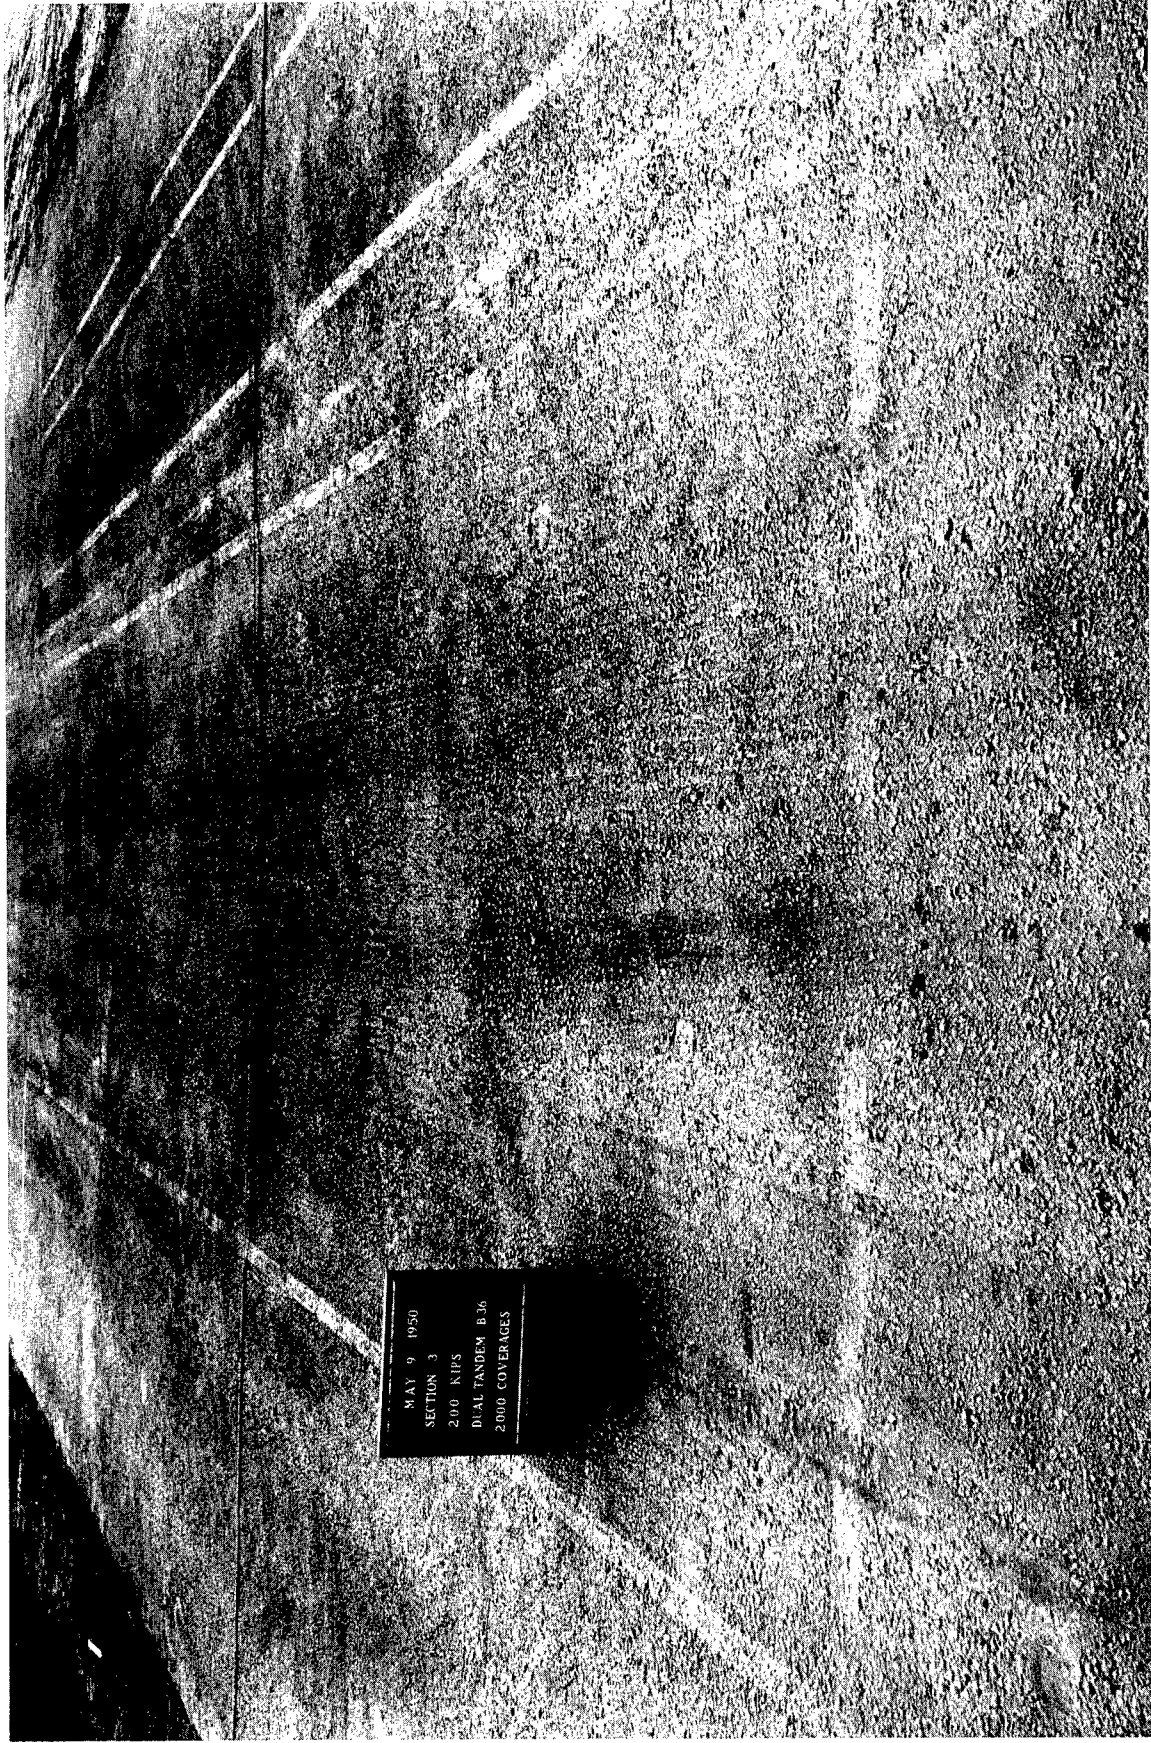
Photograph 13. Unit 3, 26-in. thickness. View after 2,000 coverages with 200,000-lb load on B-36 assembly

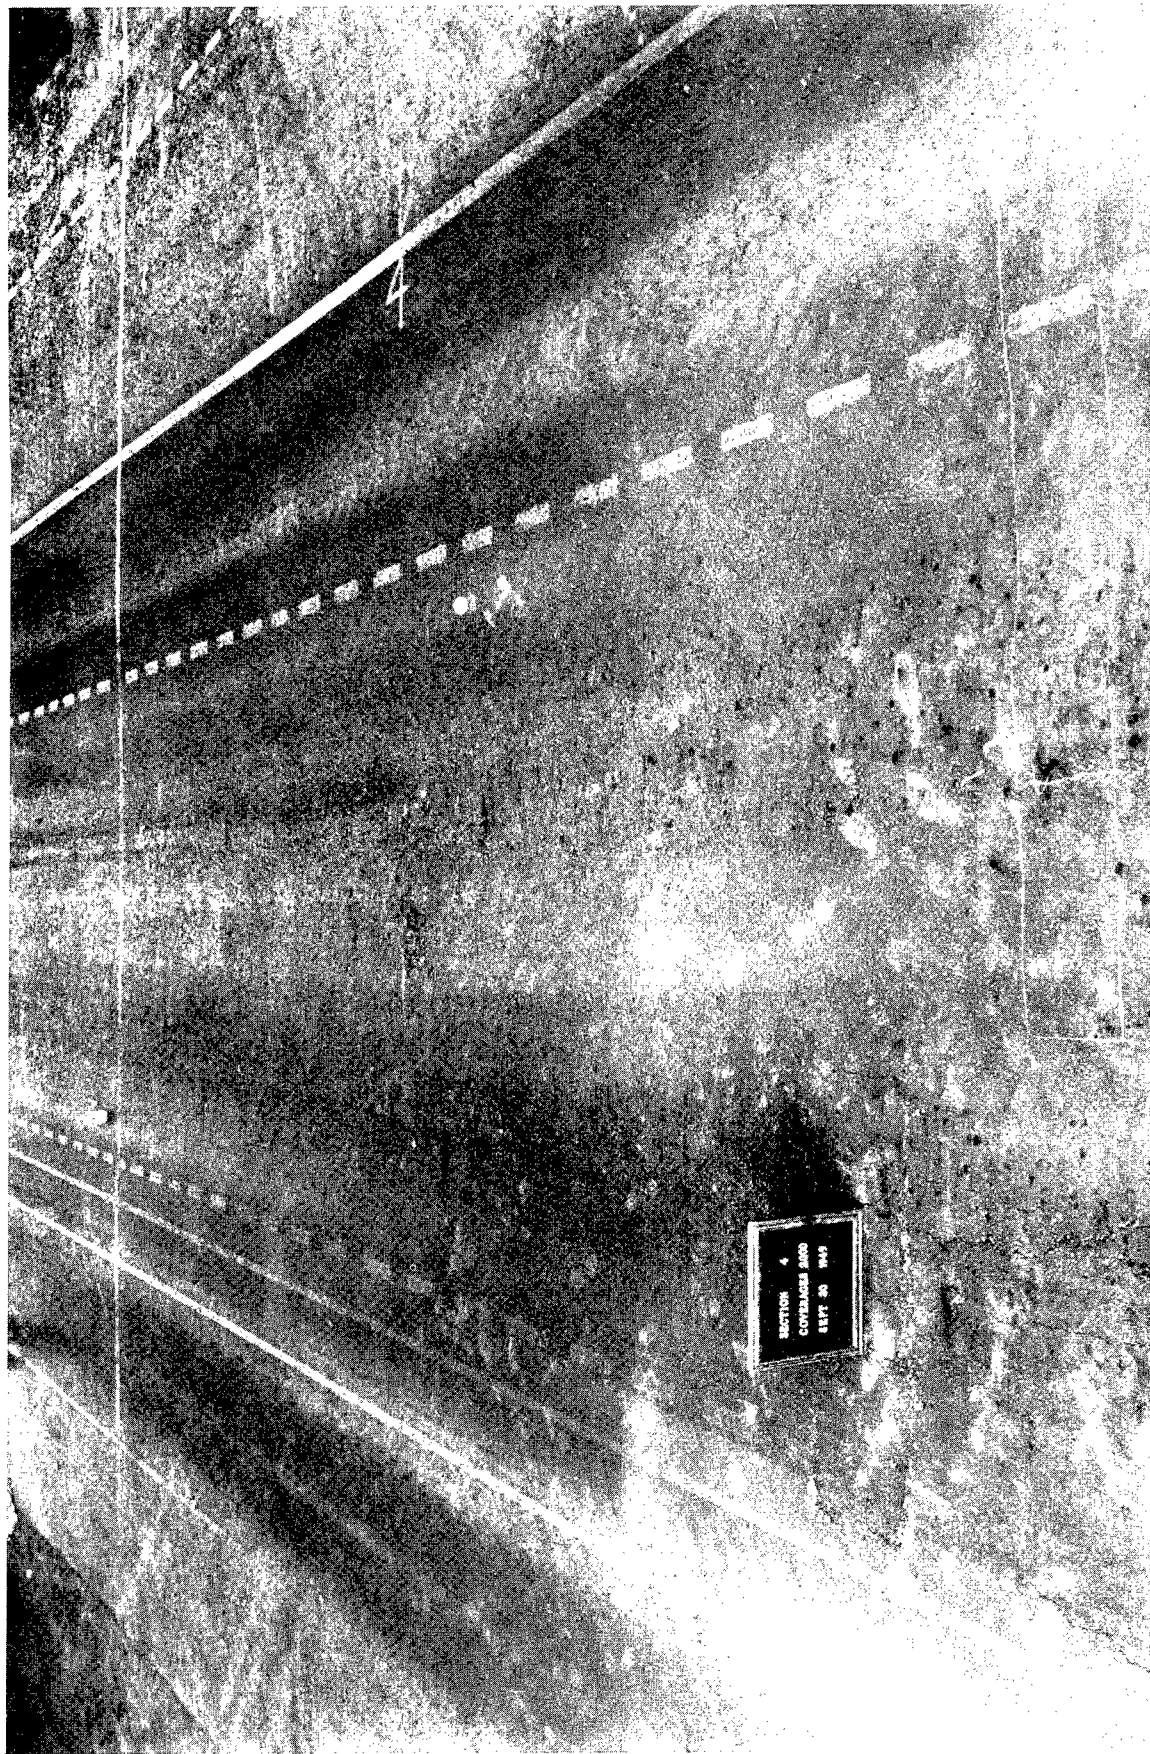
35. Unit 4, 10-in. thickness. The deflection of the subgrade under load increased from 0.208 in. at the first load application to 0.240 in. at 2,000 coverages. The maximum deformation of the surface was about 1.0 in. (see plate 14) and the maximum deformation of the subgrade at the gage point was about 0.3 in. (see plate 12). A few small cracks appeared around the core holes at station 0+06 almost from the beginning of the testing, and rutting was rather prominent over the entire unit. Both the cracks and the ruts ironed out with continued traffic until about 1,500 coverages had been applied; then the cracks opened to 1/16 in. and larger in the area near the south end of the section.

The CBR of the subgrade in this area after 1,500 coverages (pit 3) was 27 per cent. After 2,000 coverages only a small area in the southwest corner had actually failed but the development of ruts and cracks indicated a condition of incipient failure over the south end of the unit from stations 0+00 to 0+06. The condition of this area is shown in photographs 14 and 15. The CBR of the subgrade in this area after 2,000 coverages (pit 4) was 15 per cent. This area (6 ft at south end) is considered inadequate. The CBR value of 27 per cent at 1,500 coverages is considered pertinent for the analysis of this portion of the unit. Except for a slight deepening of ruts, no distress was observed in the remainder of the unit during the B-29 traffic. The CBR of the subgrade in this latter area after 2,000 coverages (pit 5) was 35 per cent. Evaluation of unit except for south 6 ft is borderline.

Photograph 14. Unit 4, 10-in. thickness. View showing cracks after 2,000 coverages with 70,000-lb load on B-29 assembly

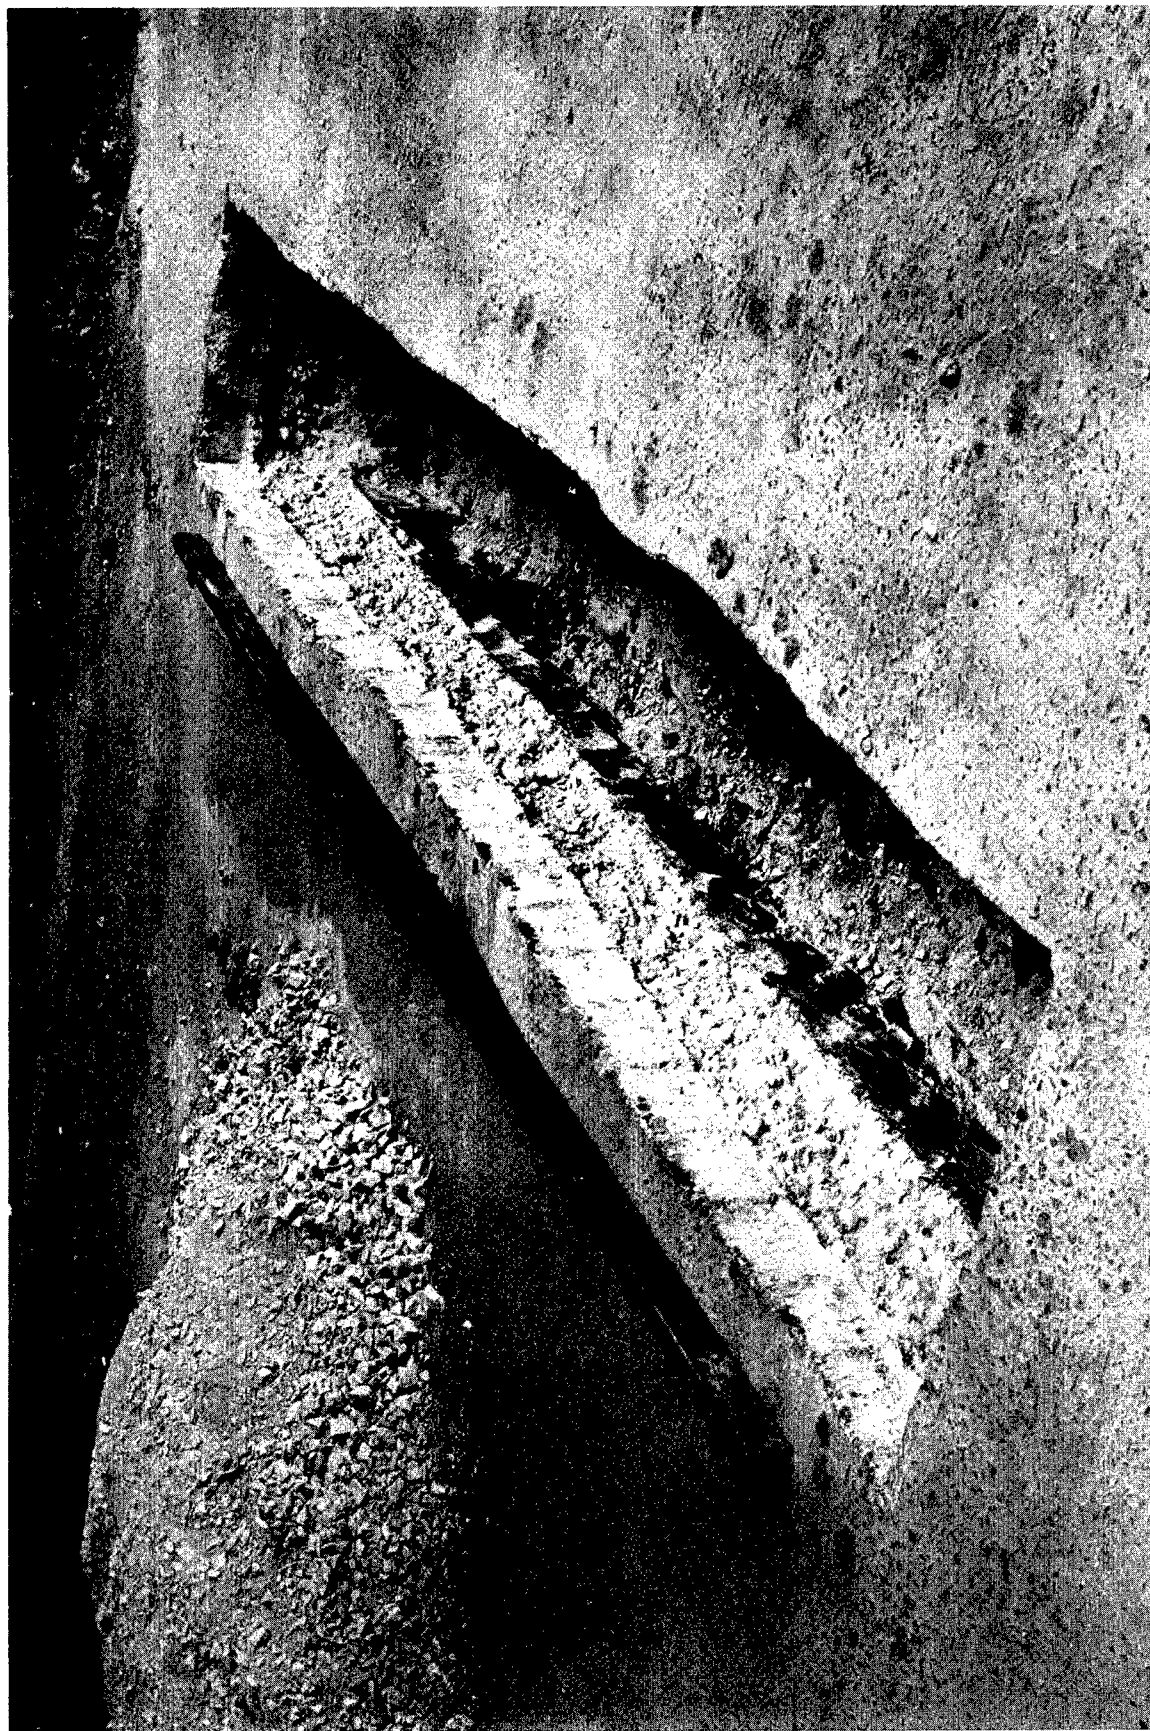
Photograph 15. Unit 4, 10-in. thickness. View of pit 4 after 2,000 coverages with 70,000-lb load on B-29 assembly

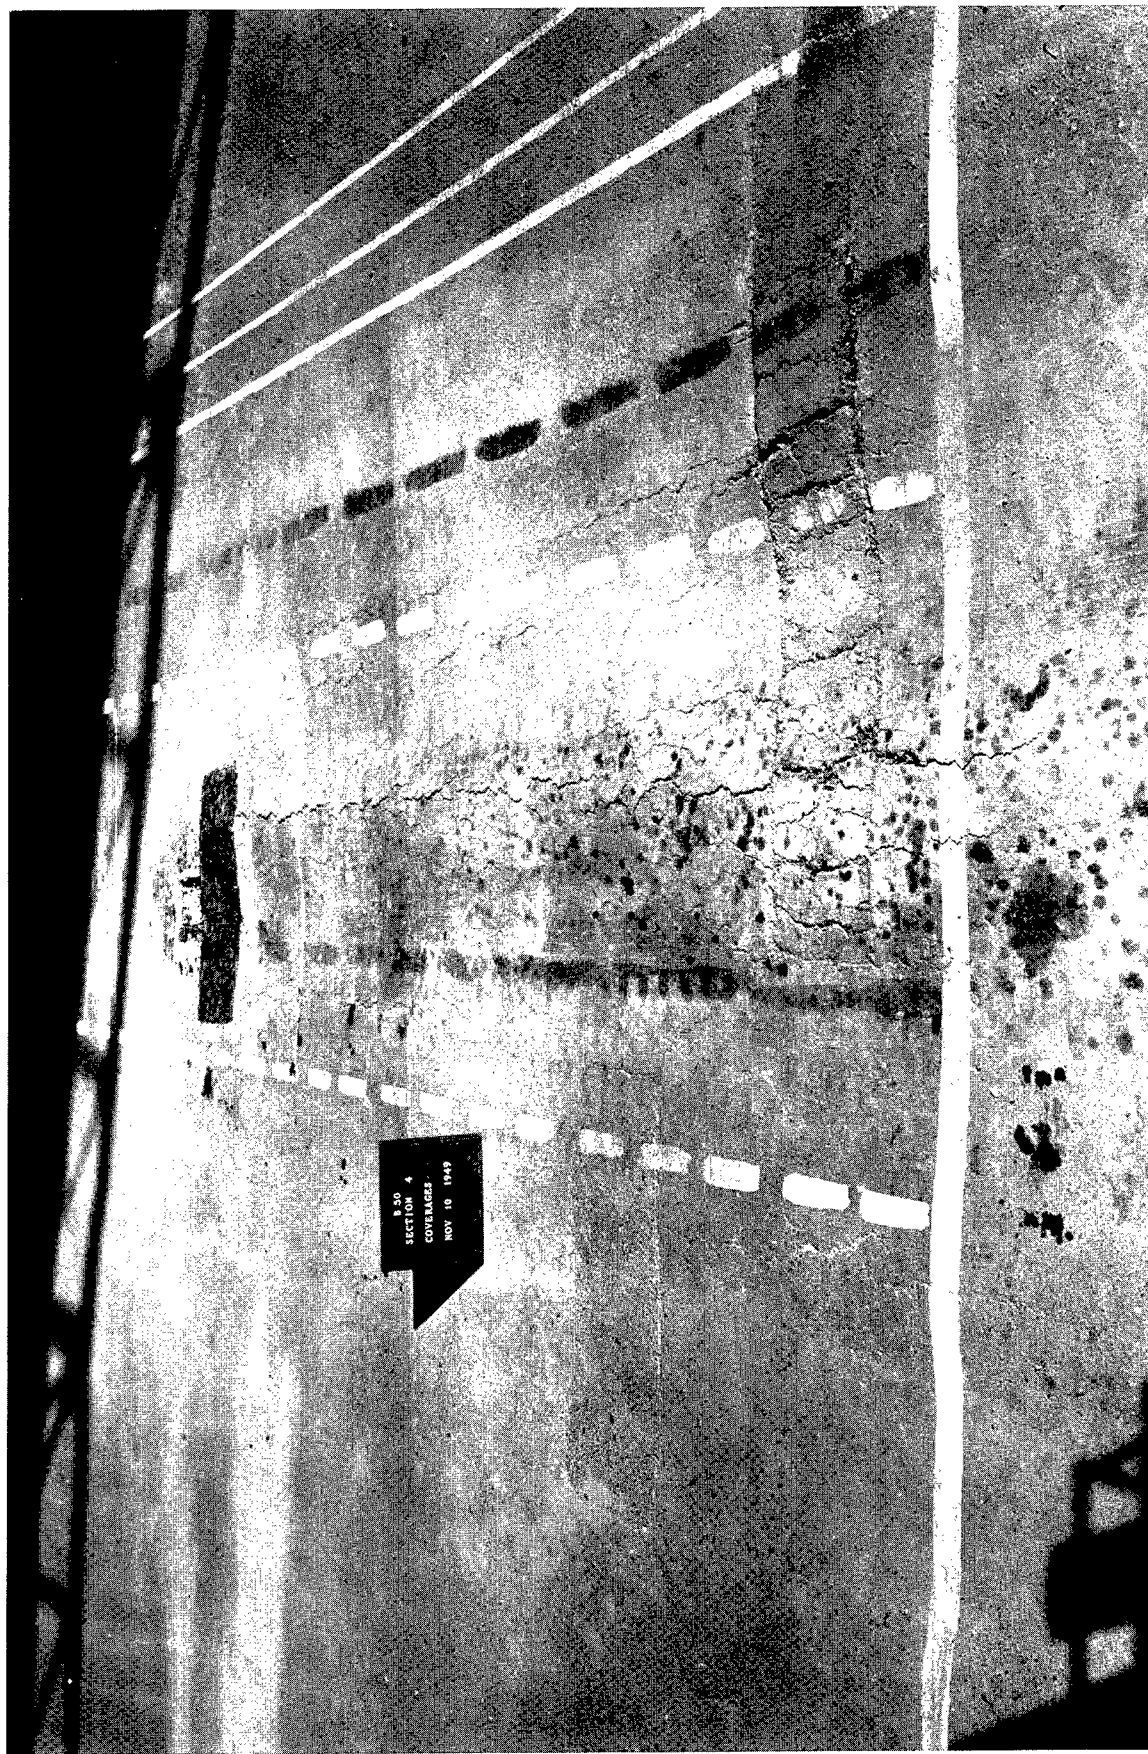
Photograph 16. Unit 4, 10-in. thickness. View showing condition of pavement after 42, 100, and 250 coverages with 100,000-lb load on B-50 assembly

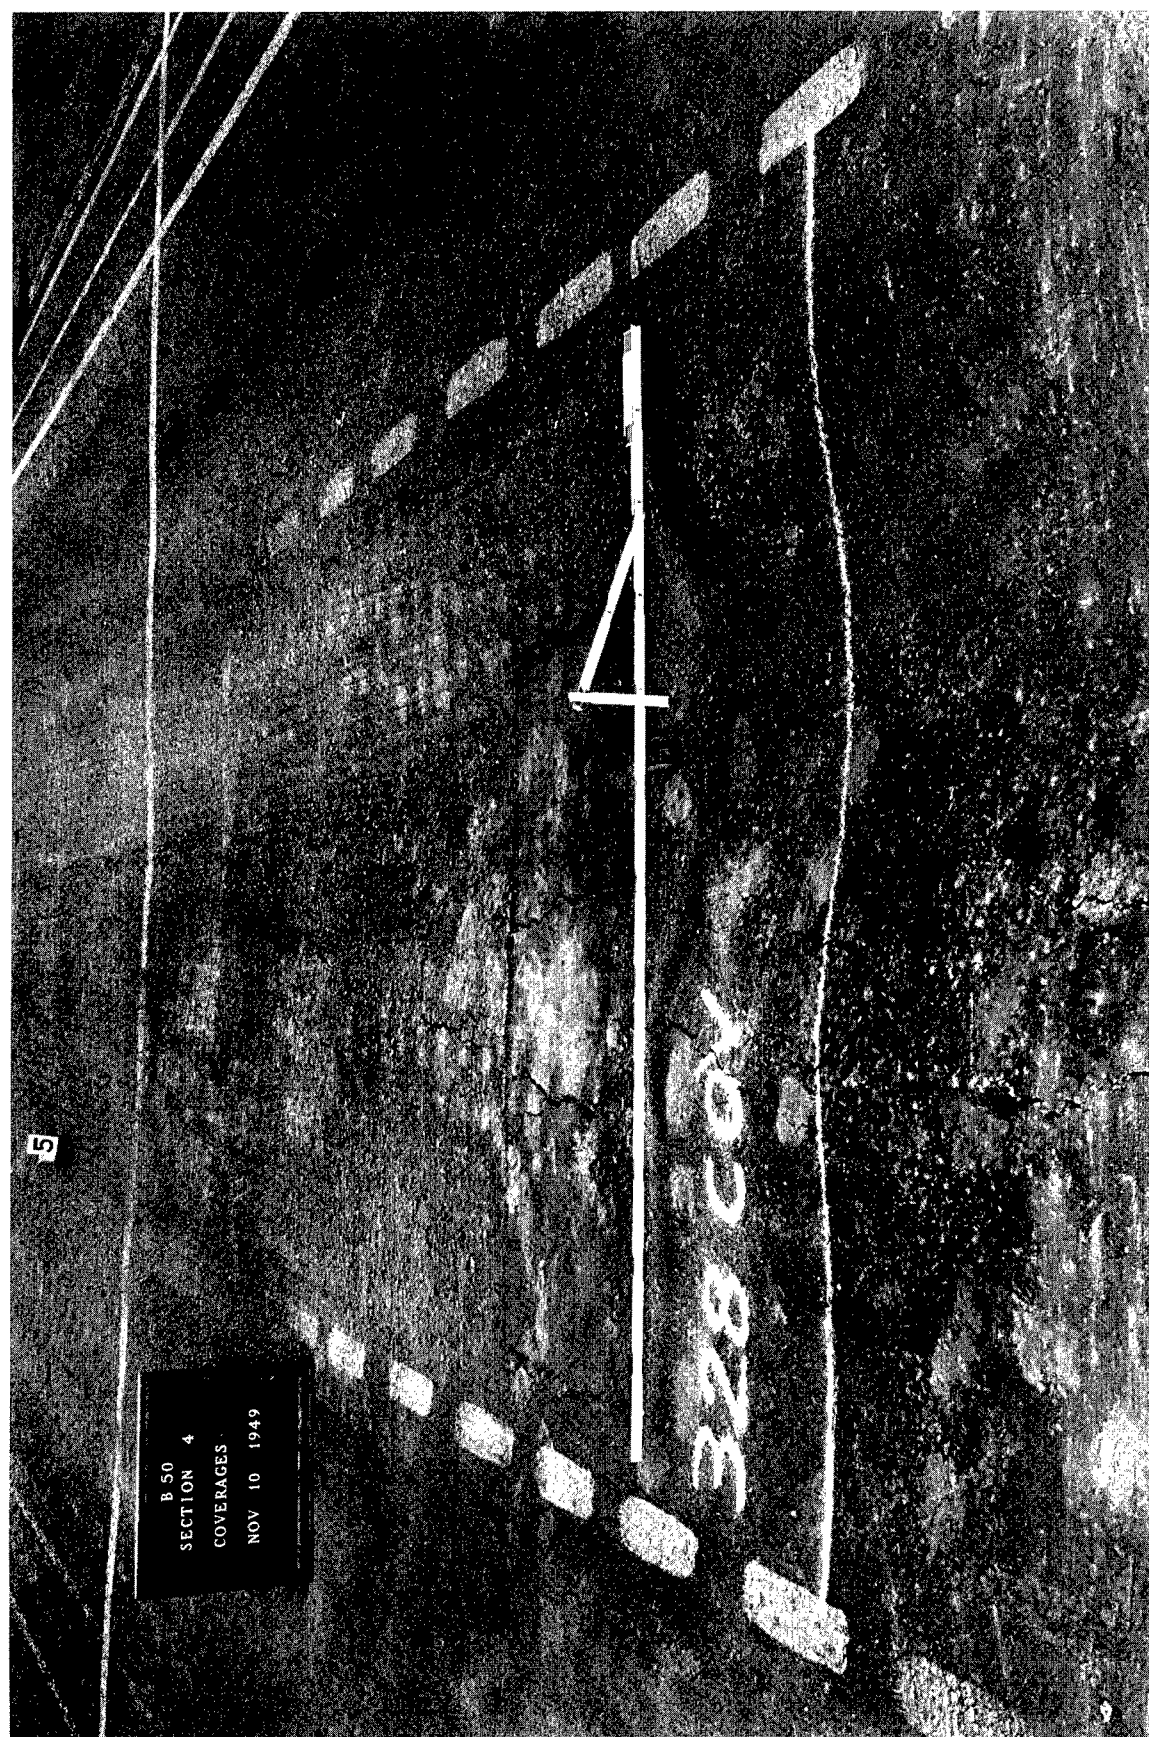
39. Unit 4, 10-in. thickness. The deflection of the subgrade under load increased from 0.305 in. at the first load application to 0.346 in. at 66 coverages. No deflection measurements were taken in this unit after 66 coverages because the pavement was so badly broken that the gage did not function properly. The maximum deformation of the surface was about 2.1 in. (see plate 14) and the maximum deformation of the subgrade at the gage point was about 0.7 in. (see plate 12). Cracking and rutting began in this unit almost from the beginning of the B-50 testing. As shown in photographs 16 and 17, the unit began to fail at about 42 coverages and had failed completely after 328 coverages. The CBR of the subgrade after 250 coverages (pit 7) was 11 per cent. Since failure occurred quickly, it is considered that the value of 35 per cent measured in this unit at the end of 2,000 coverages with the B-29 assembly (see paragraph 35) is more indicative of the strength that was present during the failing period than the value measured at 250 coverages. This

unit was evaluated as inadequate.

Photograph 17. Unit 4, 10-in. thickness. View showing condition of pavement after 328 coverages with 100,000-lb load on B-50 assembly

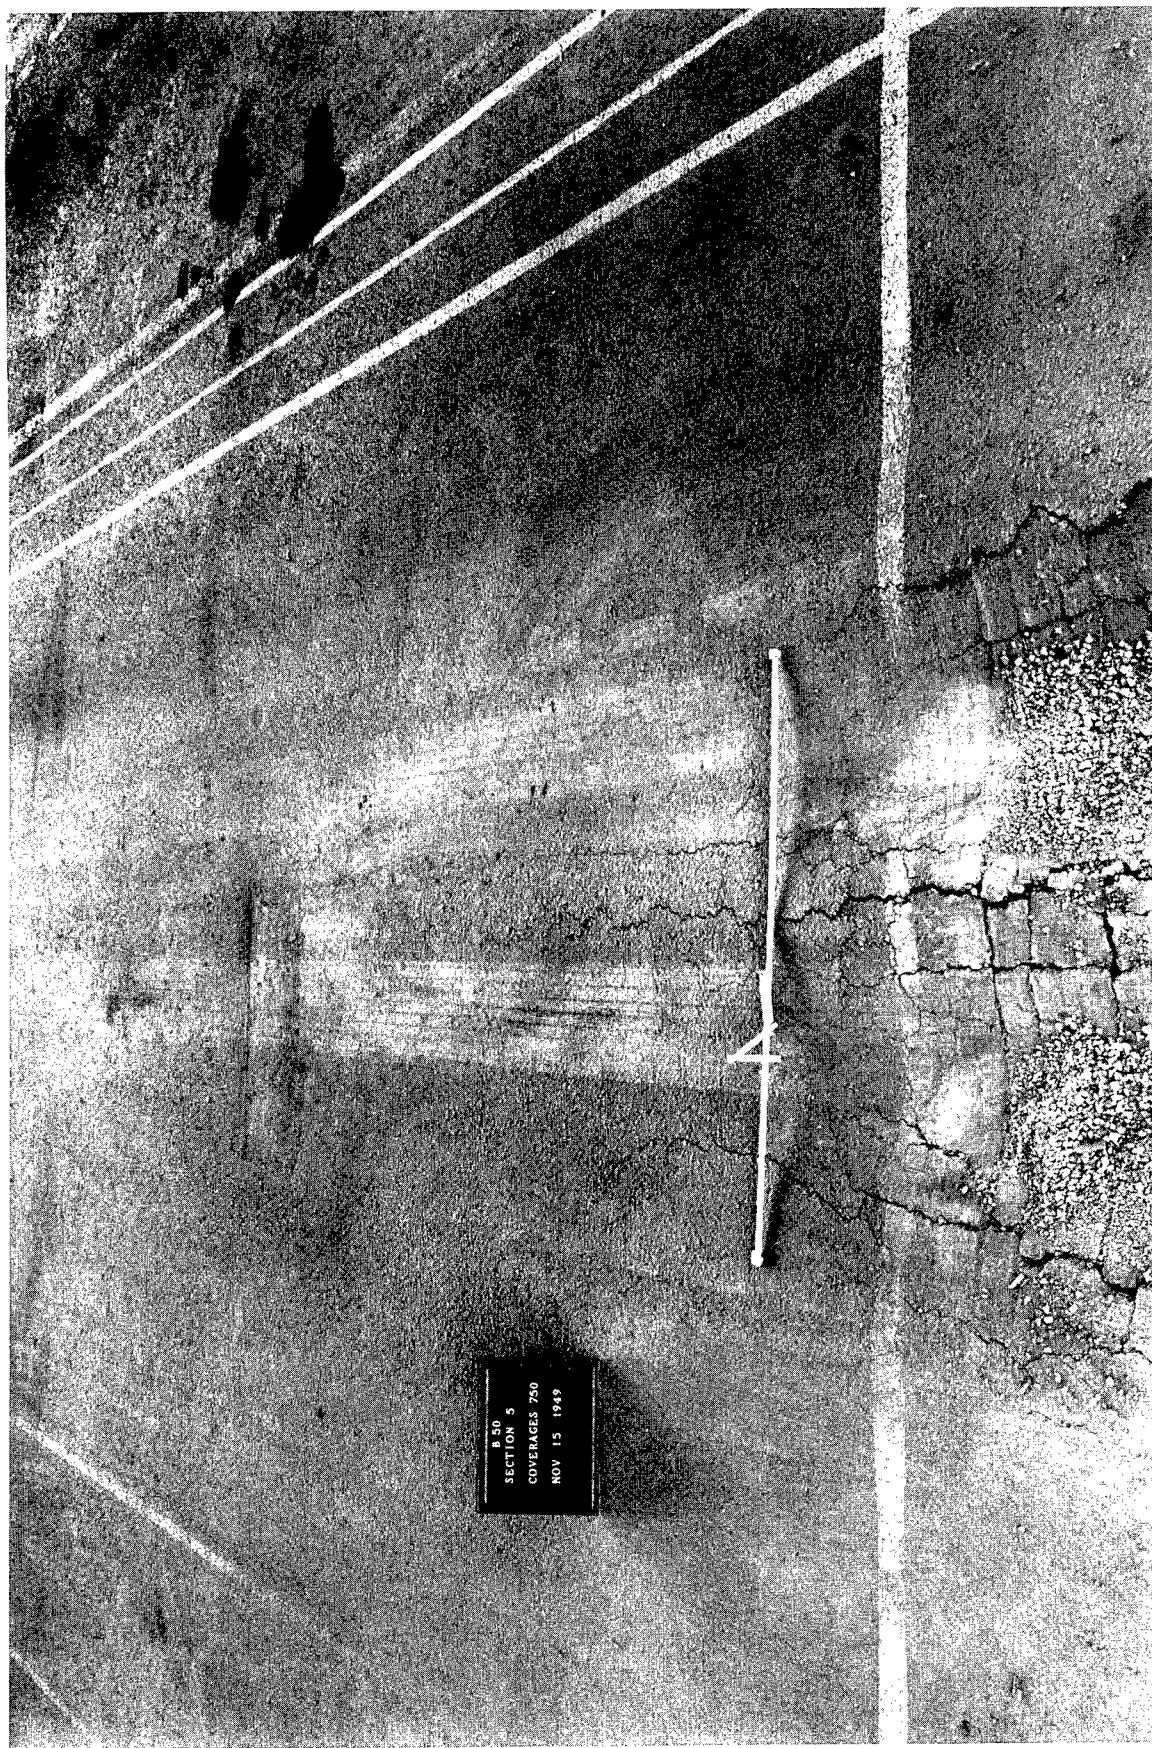
Photograph 18. Units 4 and 5, 10- and 15-in. thicknesses. View showing migration of cracks from 10- to 15-in. unit after 750 coverages with 100,000-lb load on B-50 assembly
